LANDSLIDES AND RELATED FEATURES

OF THE NEW KENSINGTON WEST, PA. QUADRANGLE

by
William E. Davies
1979

OPEN FILE MAP 79-1314 (E-2)

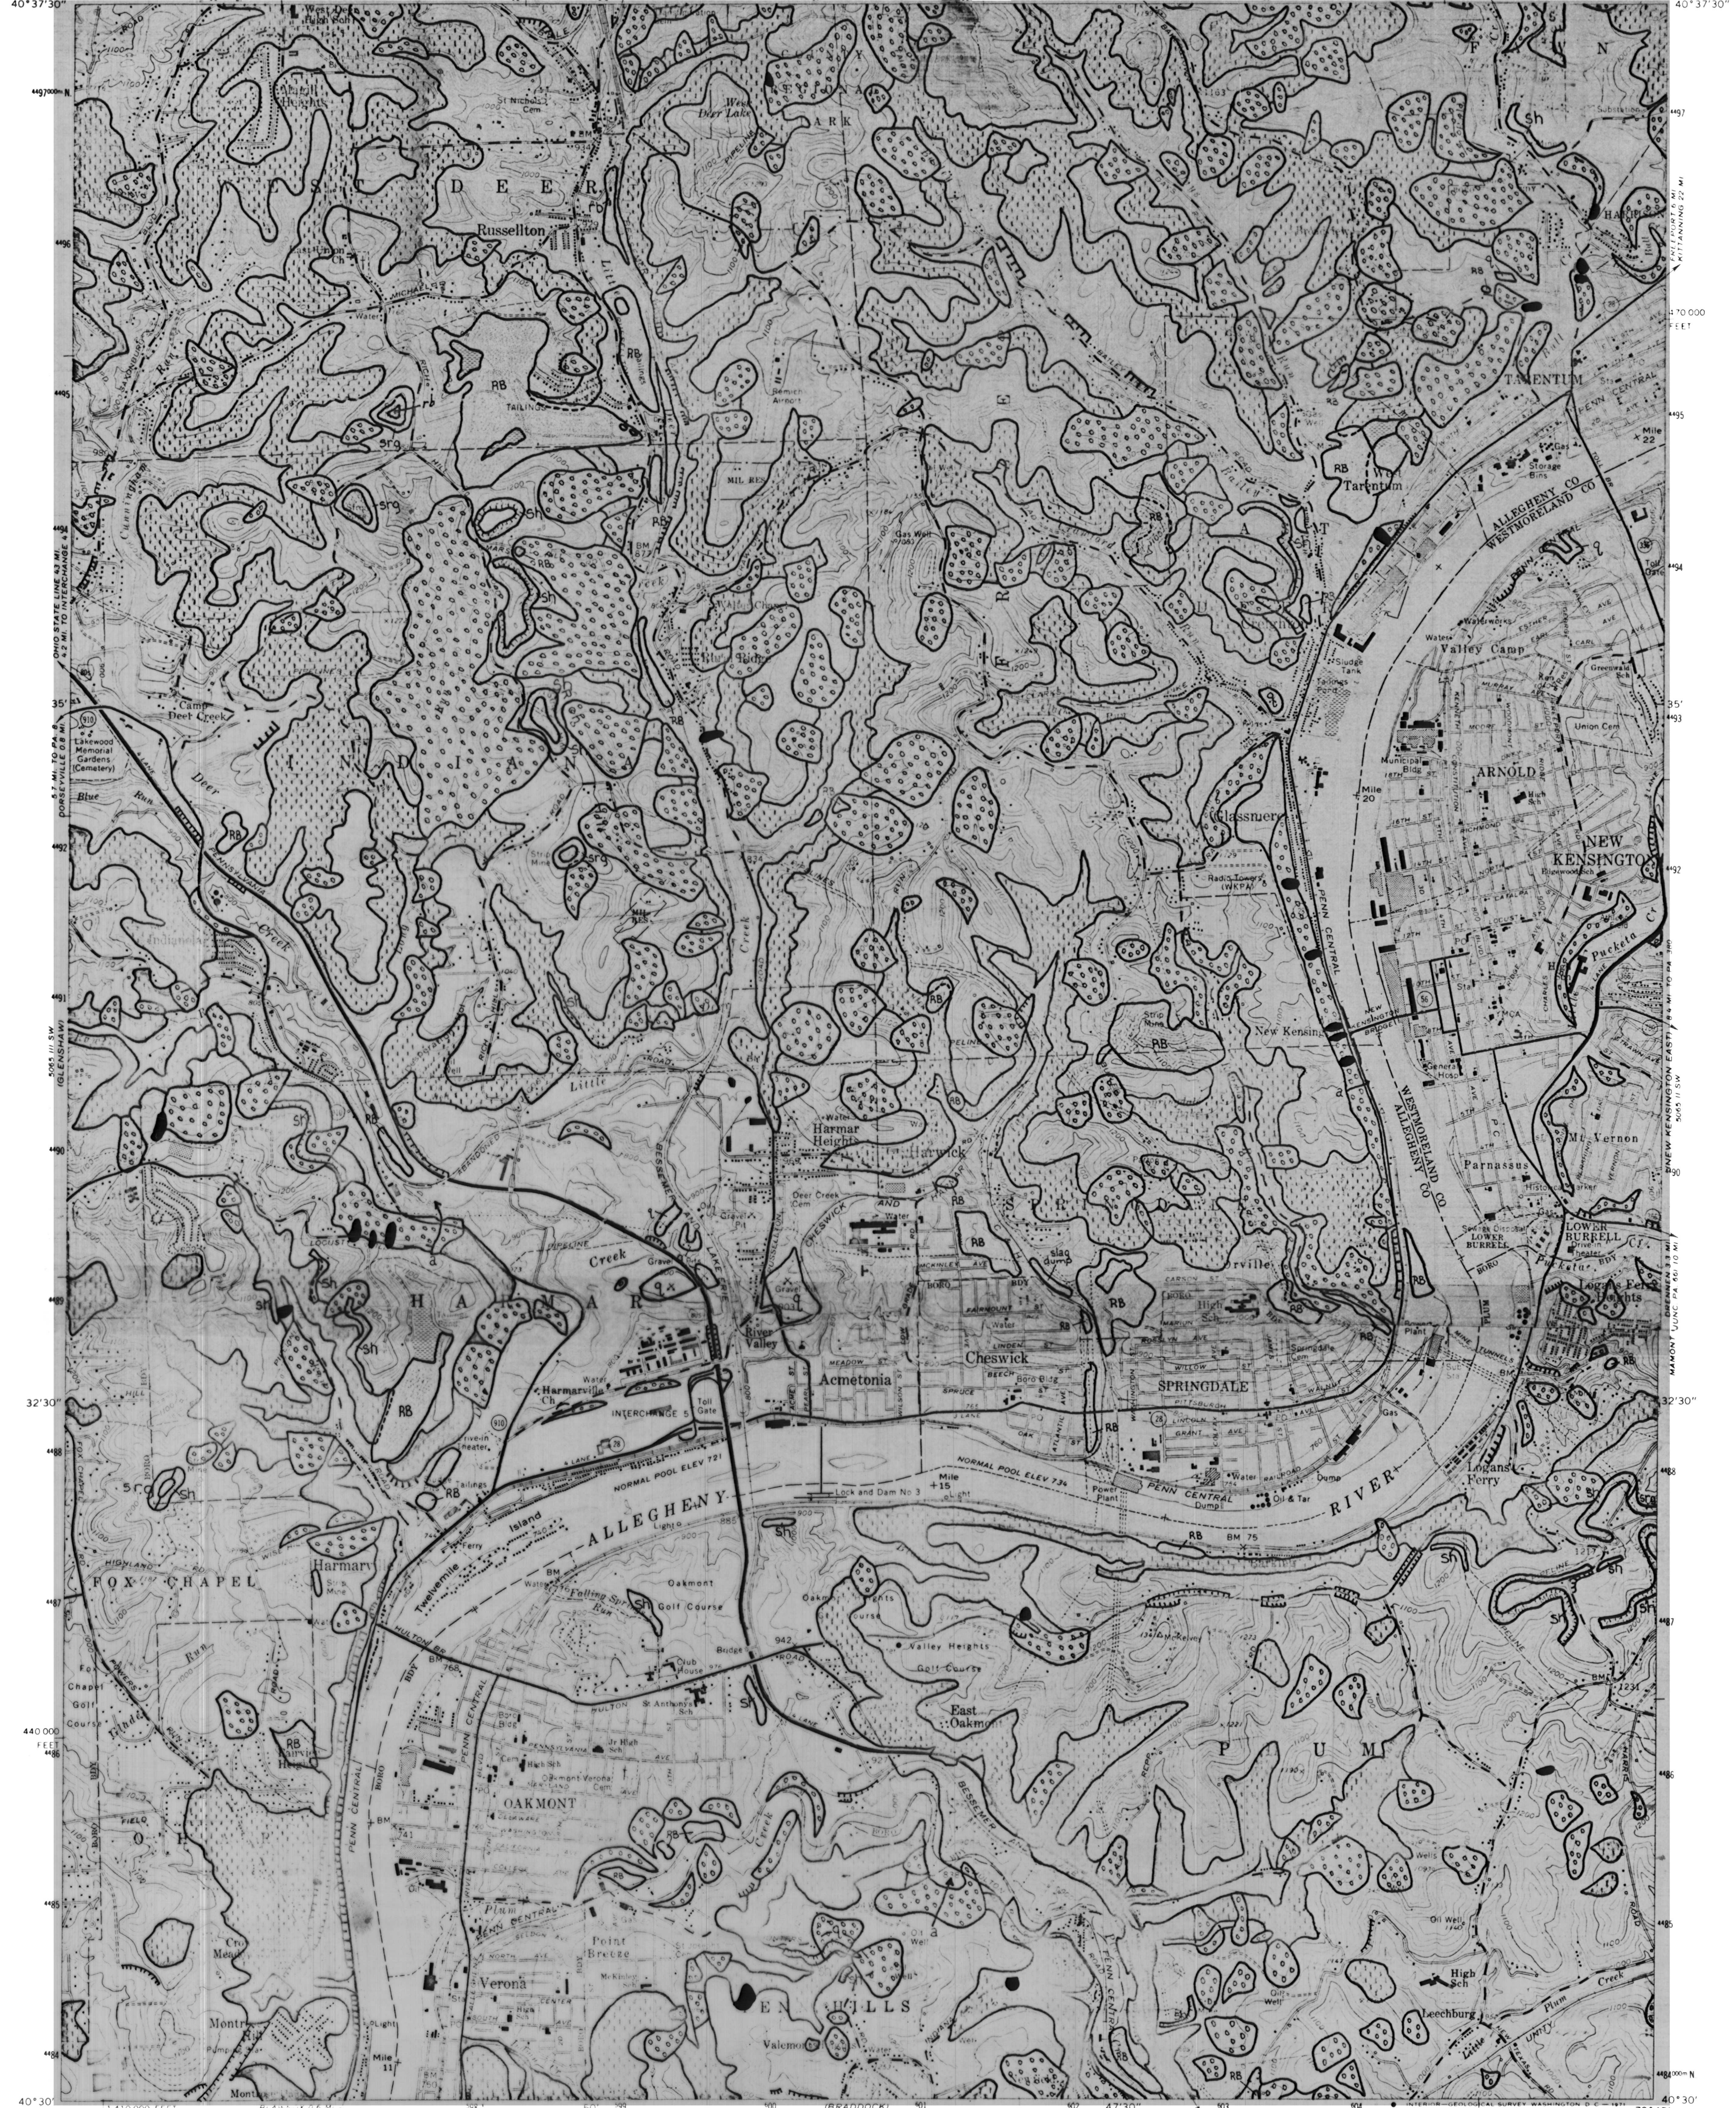
Landslides and related features interpreted from aerial photographs:
1:12,000 (black and white) 1973

Photointerpretation and field check 1974
This map has not been edited or reviewed for conformity with Geological Survey standards and nomenclature.

ACTIVE OR RECENTLY ACTIVE LANDSLIDE
Complex landslide composed of earthflow, debris slide, earth and rock slump. Identified from historical records, and from scars, debris and other field evidence. Ground extremely unstable; sliding accelerated by excavation, loading and changes in drainage conditions. May include areas with several active slides too small to be shown separately. Questioned where doubtful.

OLD LANDSLIDE
Area of extensive hummocky ground caused by earthflow and earth and rock slump. Lacks clear evidence of active sliding. Relatively stable in natural, undisturbed state, generally not affected by small structures properly sited in areas away from the edge of the toe; can be reactivated by extensive, rapid excavation, loading, and changes in ground water and surface water conditions. Area of old landslide probably includes recent ones not identified from field evidence or otherwise documented. Upslope boundary of landslide generally defined by modified scarp, but downslope (toe) may be gradational and not well defined. Questioned where doubtful.

COMBINATION LANDSLIDE
Area of recent and old slides in which individual slides are not identified.

COLLUVIAL SLOPE
Valley wall along major streams with slope as steep as 40° (85%); stony, clayey silt soil up to 50 ft. (15 m) thick; commonly buttressed by a terrace or bench at the toe of the slope; very susceptible to sliding by cutting of toe area, removal of terrace or bench, and overloading; slide commonly activated without apparent cause.

SCREE
Residual accumulations of coarse rock material lying on quartzite slopes of the Valley and Ridge province. Generally stable except where subjected to extreme rainfall.

COLLUVIAL SLOPES WITH LANDSLIDES
Landslides too small or obscure to map individually.

AREAS SUSCEPTIBLE TO DEBRIS FLOWS AND DEBRIS AVALANCHES
Primarily shallow, narrow ravines and chutes with accumulation of stony colluvium generally 10 ft. (3 m) or less in thickness; susceptible to rapid movement during intense rainfall. Most ravines and chutes designated show evidence of former debris flows and avalanches. Symbol & designates historical debris flow or debris avalanche.

AREAS SUSCEPTIBLE TO ROCKFALL
Steep, locally vertical, natural and man-made slopes and cliffs, 15 ft. (4.5 m) or more high; formed dominantly of sandstone, limestone, sandy shale, mudstone and claystone. Interbedded mudstone, claystone and shale weather rapidly leaving sandstone and limestone rock faces unsupported.

SOIL AND ROCK SUSCEPTIBLE TO LANDSLIDING
Soil and rock similar to that involved in landslides elsewhere in map area; primarily areas underlain by claystone, mudstone and shale associated with other rock types. Rock weathers rapidly on exposure forming clayey soil highly susceptible to sliding. Includes coves (U-shaped, shallow valleys) containing thick layers of clayey soil that are very susceptible to sliding where excavation breaks continuity of slope and where overtopped by artificial fill.

AREAS LEAST PRONE TO LANDSLIDES
Map areas in which no patterns or symbols are shown; primarily valley floors, ridge tops and broad benches; modification by excavation and fill may lead to local landslides. Includes slopes where landslides are sparse.

NOTE
Information shown is intended as a general guide to ground conditions as of the date of field check. Additional landslides and rockfalls should be anticipated in all map units. The map unit depicts the dominant condition in the area delineated and variations in slope stability may occur at any point in the unit. This map is suitable for general planning purposes and as a supplement to more detailed studies for site selection. The map cannot be used as a substitute for detailed geologic and engineering investigations to establish design and construction criteria of specific sites. Some symbols may not appear on this map because the description is applicable to a series of maps.
